INSPECTION REPORT

For the Property at:
123 SAMPLE STREET
WINNIPEG, MB

Prepared for: JOHN HOMEBUYER
Inspection Date: Saturday, July 23, 2005
Prepared by: Roger Chamberland

Report No. 1107

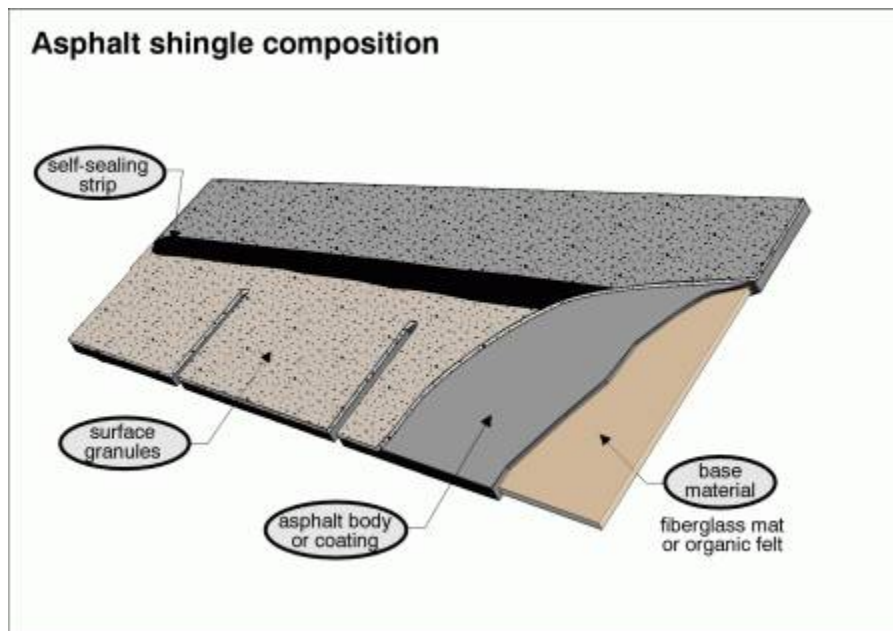
Sloped roofing \ Asphalt shingles - wear or damage

Condition: • [Granule loss](#)

Implication(s): Risk of water damage to contents, finishes and structure

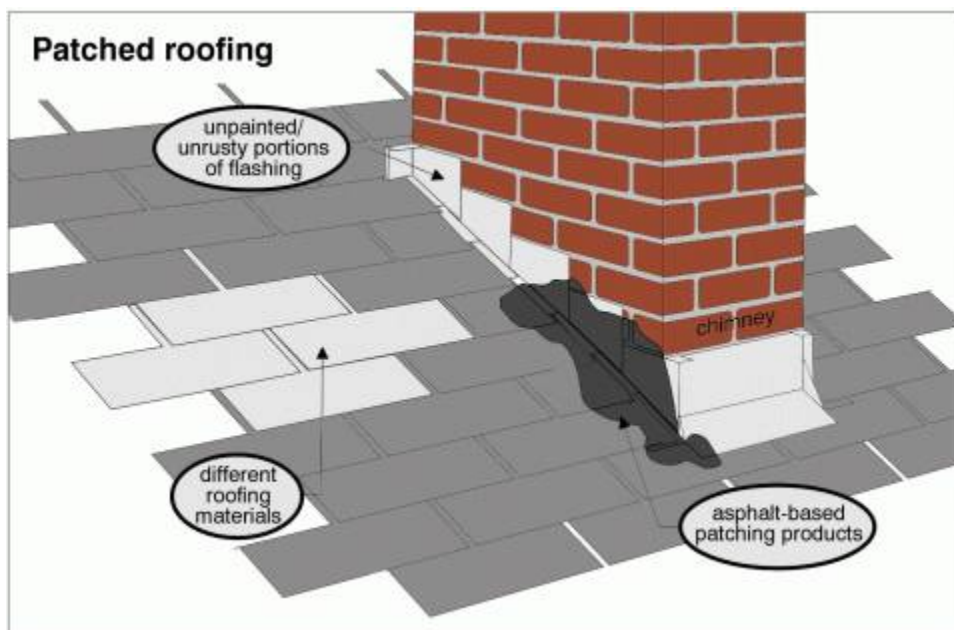
Sloped roofing \ Asphalt shingles - wear or damage

Condition: • [Patched](#)

Implication(s): Risk of water damage to contents, finishes and structure

Location: Northeast

Task: Repair

Time: Immediate

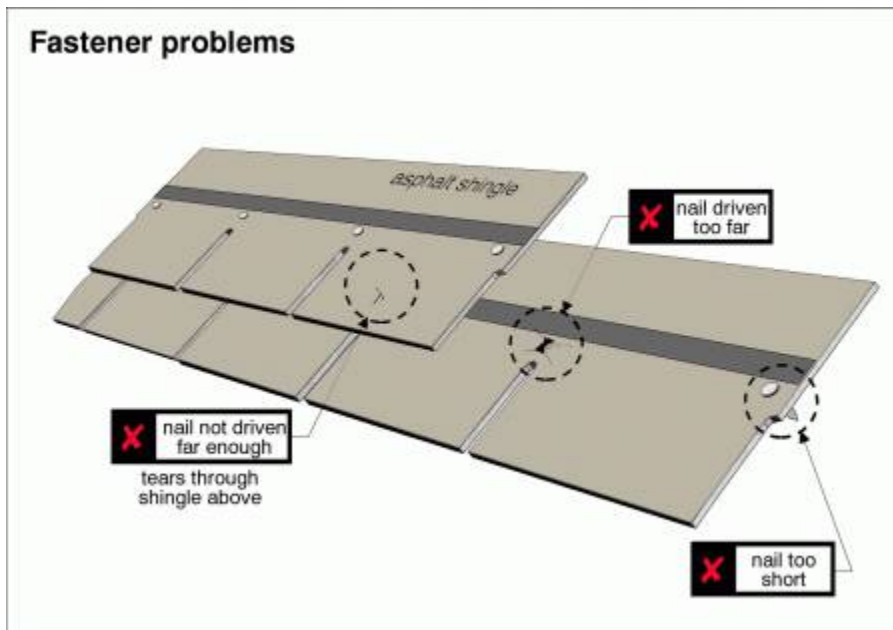
Sloped roofing \ Asphalt shingles - installation

Condition: • [Exposed fasteners](#)

Implication(s): Risk of water damage to contents, finishes and structure

Location: Various

Task: Repair

Time: Immediate

Note: Re-fasten and seal tops of nail heads with roofing cement.

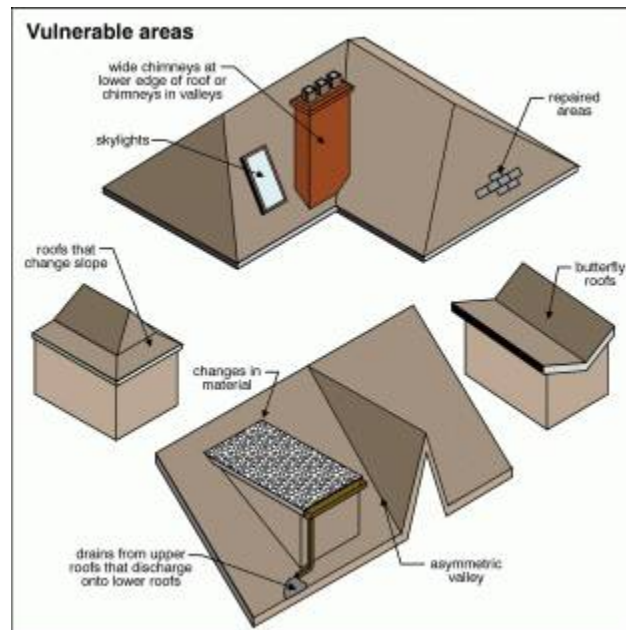
Sloped roofing \ Asphalt shingles - installation

Condition: • [Vulnerable areas](#)

Implication(s): Risk of water damage to contents, finishes and structure

Location: South Second floor

Note: Fascia board is installed higher than eave in south area causing shingles to have a dip and trap water.

Task: Repair

Time: Immediate

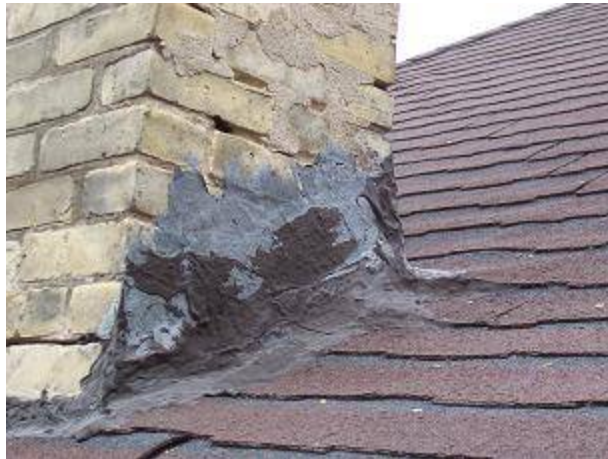
Sloped roof flashings \ Chimney flashings

Condition: • [Damage, loose, open seams, patched](#)

Implication(s): Risk of water damage to contents, finishes and structure

Task: Repair or replace

Time: Immediate

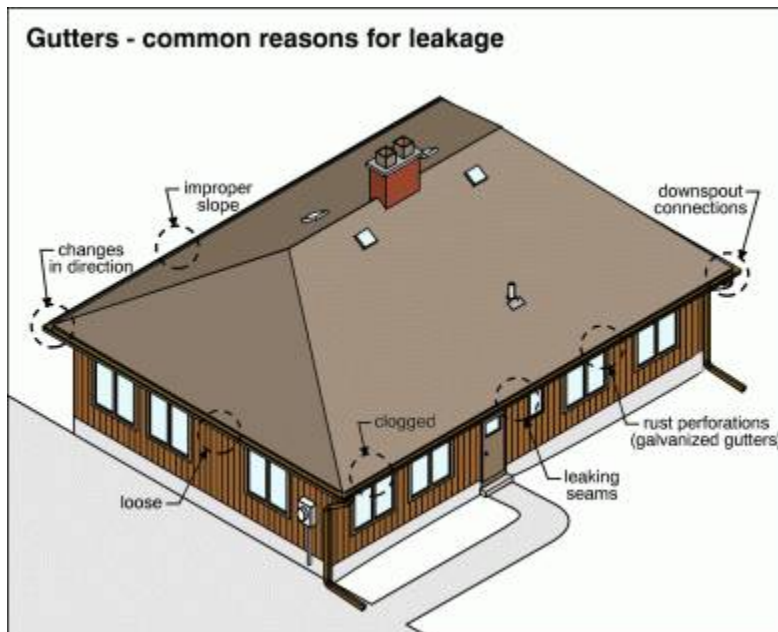
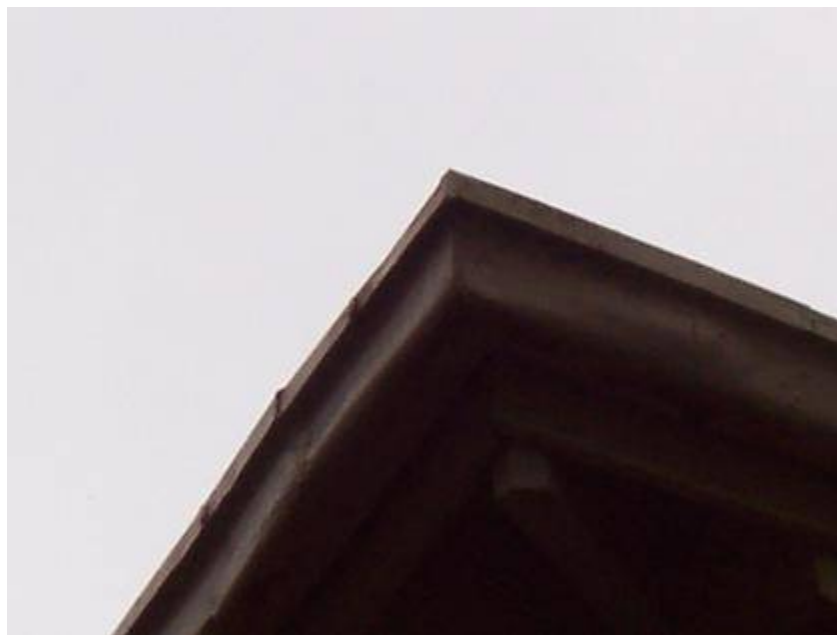
Roof drainage \ Gutters

Condition: • [Leak](#)

Implication(s): Risk of water damage to contents, finishes and structure

Location: various

Note: Rusted through. Full replacement of system recommended.

Task: replace

Time: Immediate

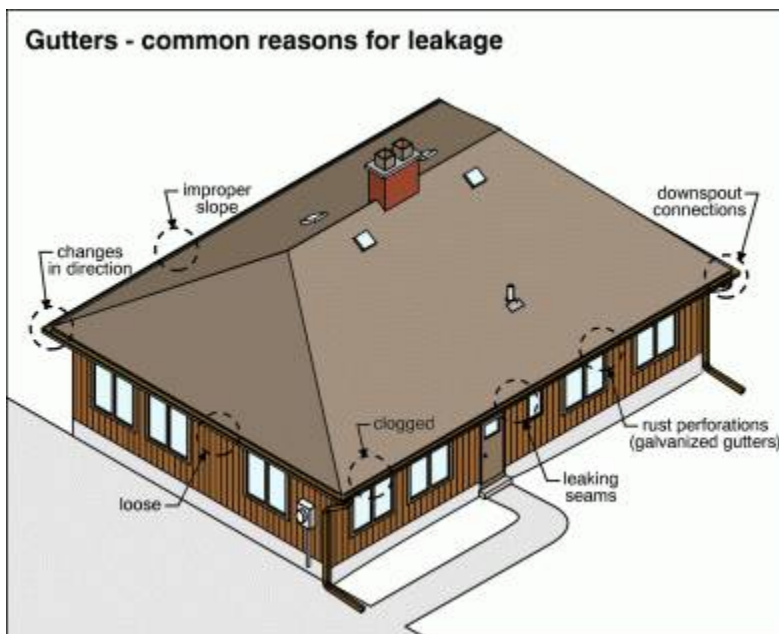
Roof drainage \ Gutters

Condition: • [Rust](#)

Implication(s): Risk of water damage to contents, finishes and structure

Location: various

Task: Replace

Time: Immediate

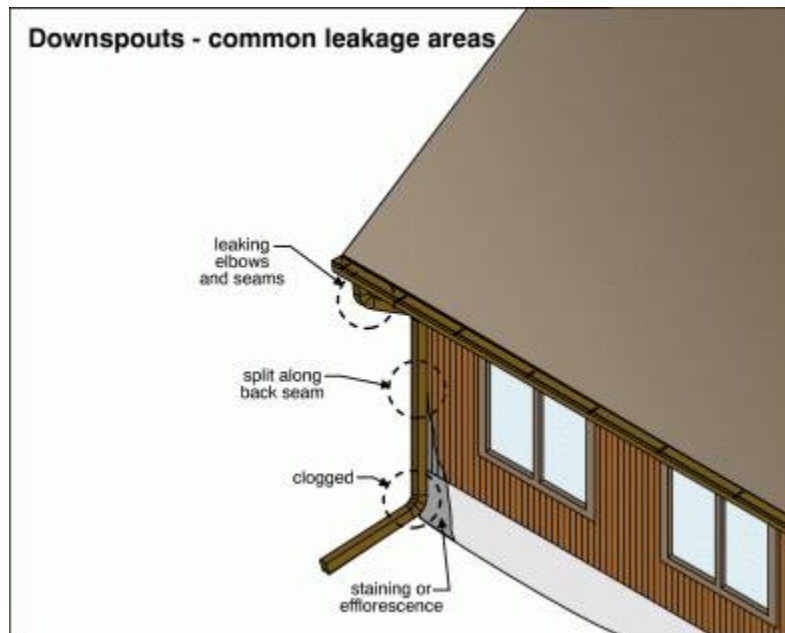
Roof drainage \ Downspouts

Condition: • [Leak](#)

Implication(s): Risk of water damage to contents, finishes and structure

Location: Throughout

Note: Split from clogs and freezing water

Task: Repair or replace

Time: Immediate

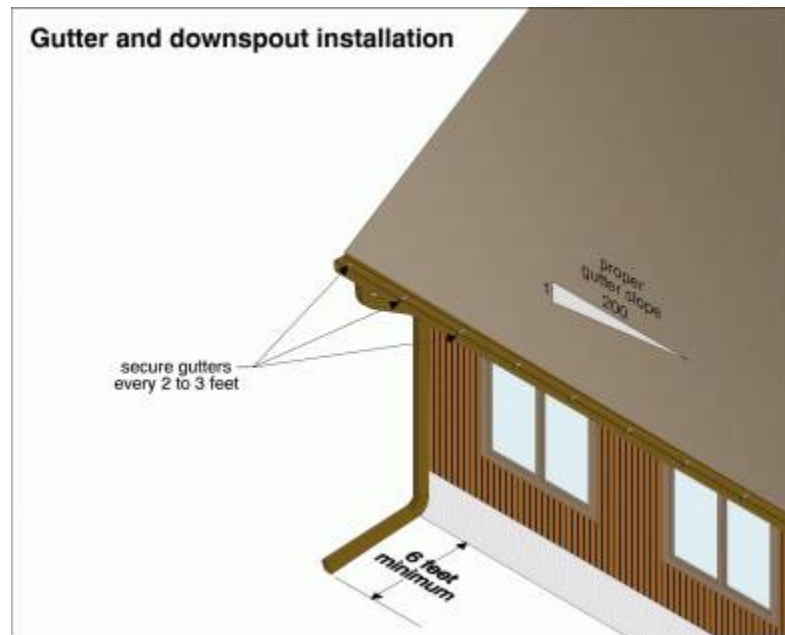
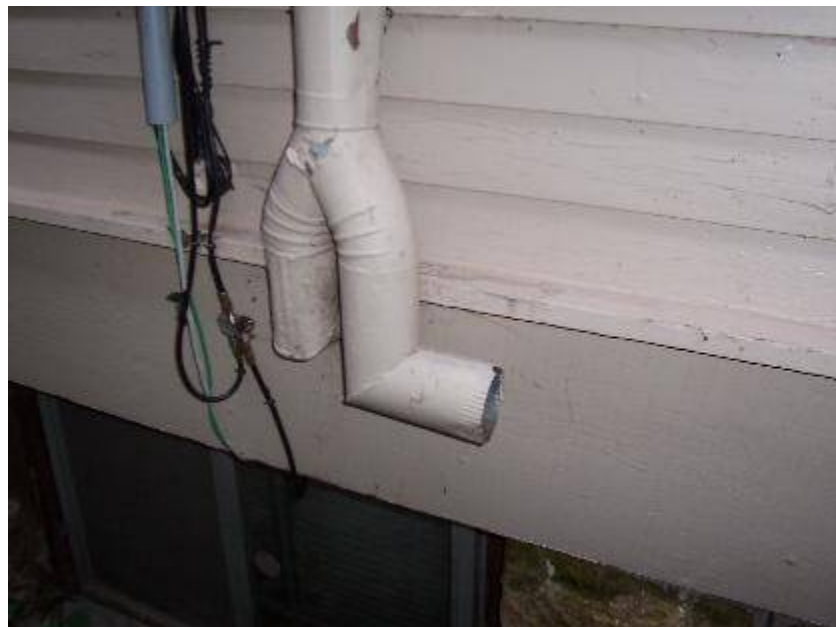
Roof drainage \ Downspouts

Condition: • [Downspouts end too close to building](#)

Implication(s): Risk of water damage to contents, finishes and structure

Location: North Exterior

Task: Improve

Time: Immediate

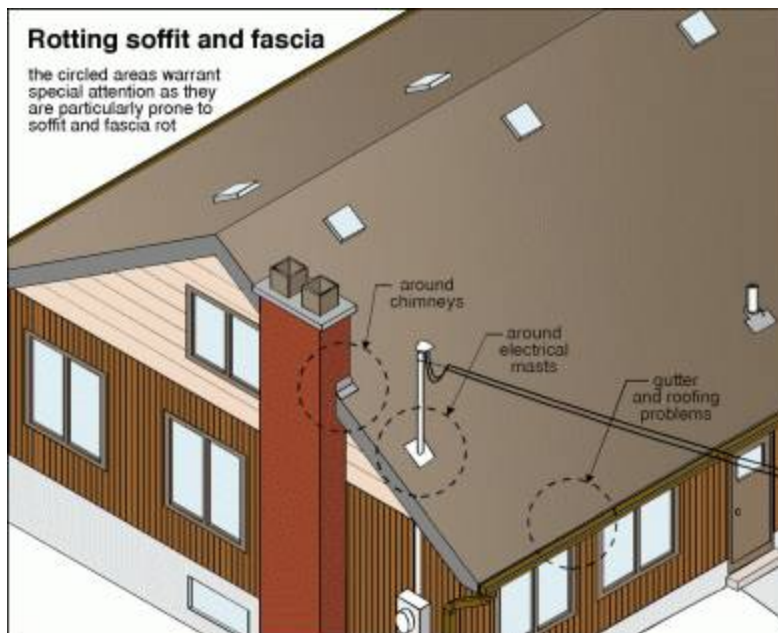
Walls \ Soffits and fascia

Condition: • [Rot or insect damage](#)

Implication(s): Cosmetic defects | Risk of water damage to contents, finishes and structure | Material deterioration

Location: Throughout

Task: Replace

Time: Discretionary

Note: Replace when replace eavestrough system

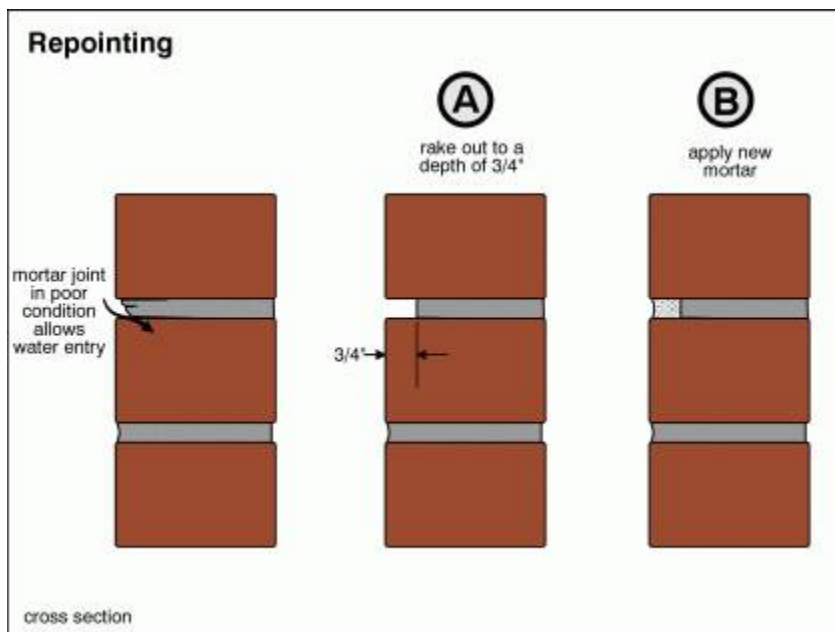
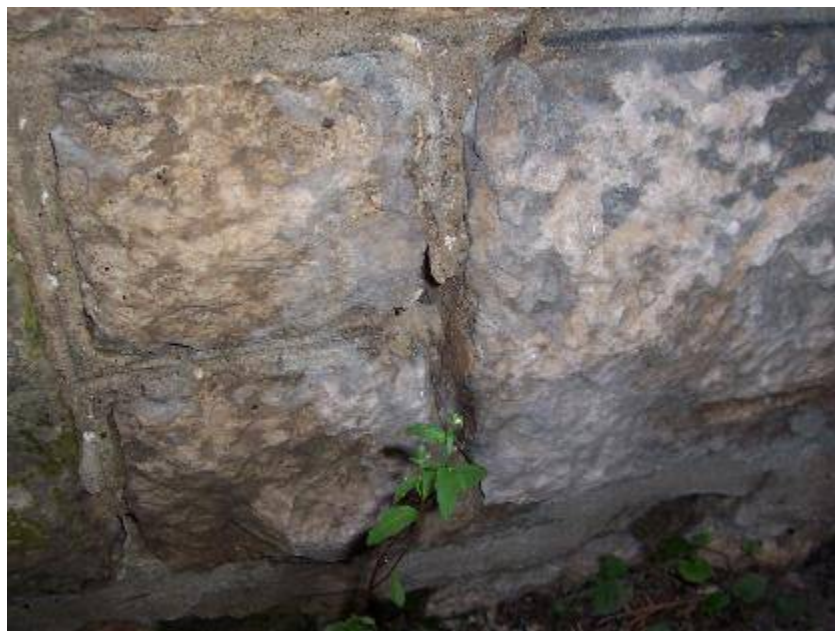
Walls \ Brick, stone and concrete

Condition: • [Mortar deterioration](#)

Implication(s): Risk of water entering house | Weakened structure | Risk of structural failure

Location: Various

Note: Foundation walls in need of repointing

Task: Repair

Time: Immediate

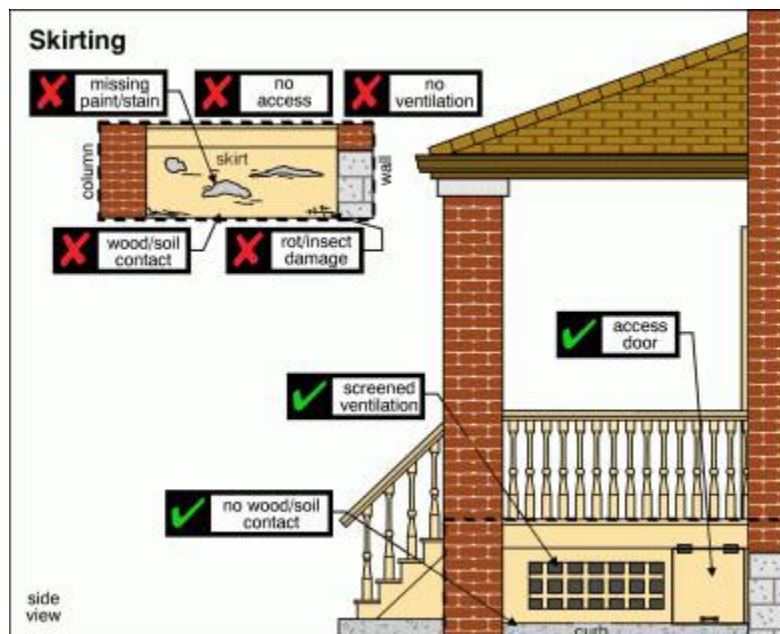
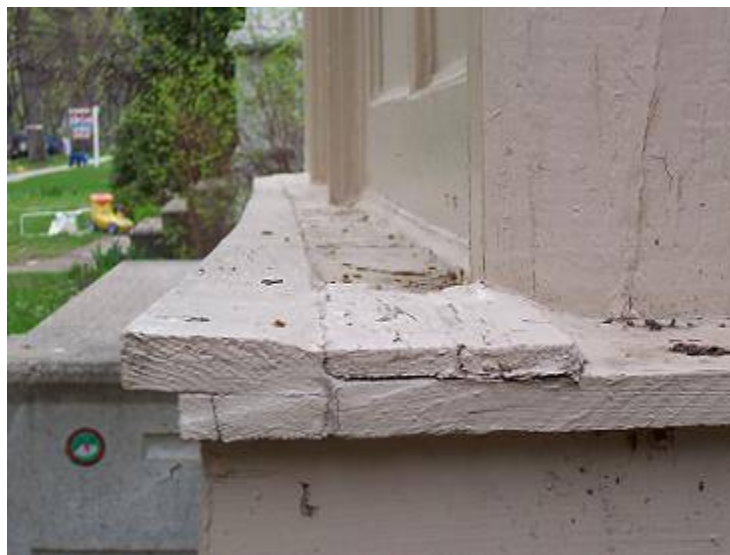
Porches, decks, patios and balconies \ Skirting

Condition: • [Rot or insect damage](#)

Implication(s): Material deterioration

Note: Back and front porch skirting. Front porch trapping water on horizontal projections causing rot.

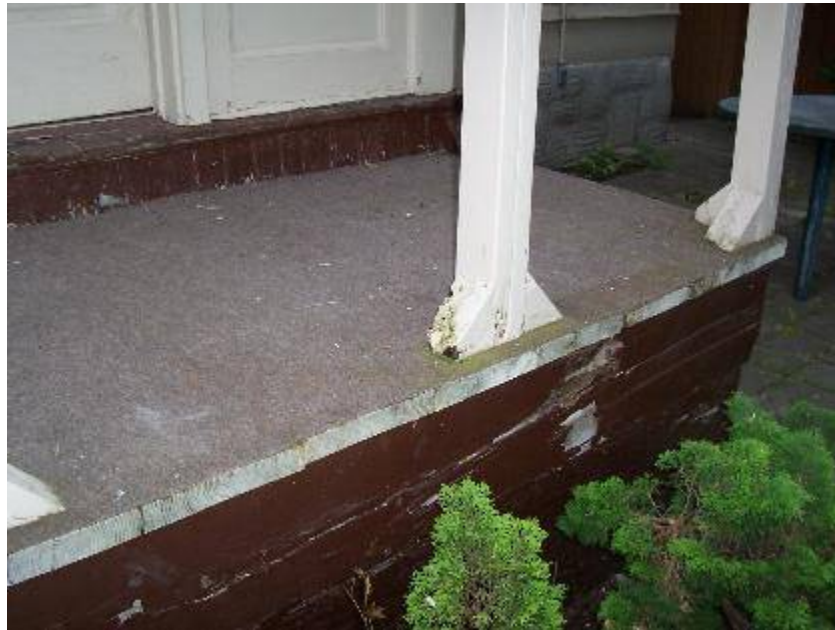
Porches, decks, patios and balconies \ Skirting

Condition: • [Wood/soil contact](#)

Implication(s): Rot

Note: Back porch skirting

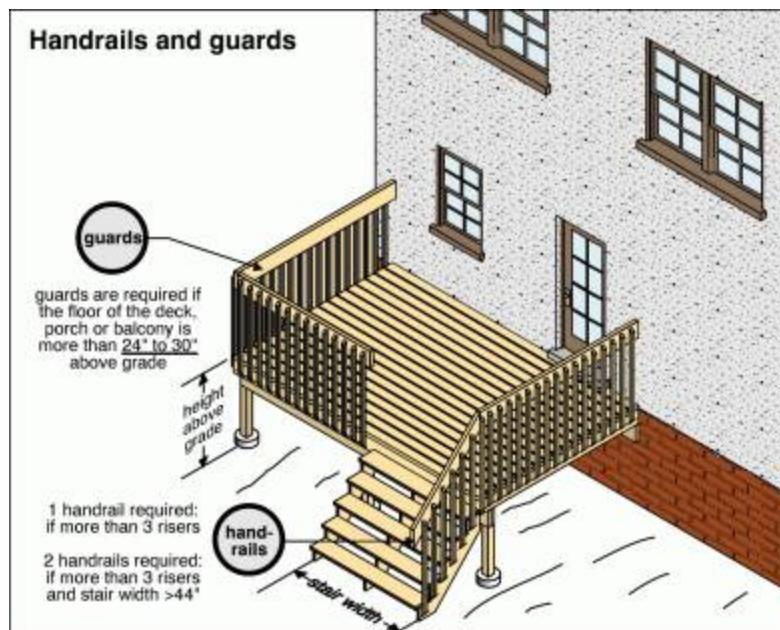
Porches, decks, patios and balconies \ Handrails and guards

Condition: • [Missing](#)

Implication(s): Health/safety hazard--fall hazard

Location: Front Porch

Task: Provide

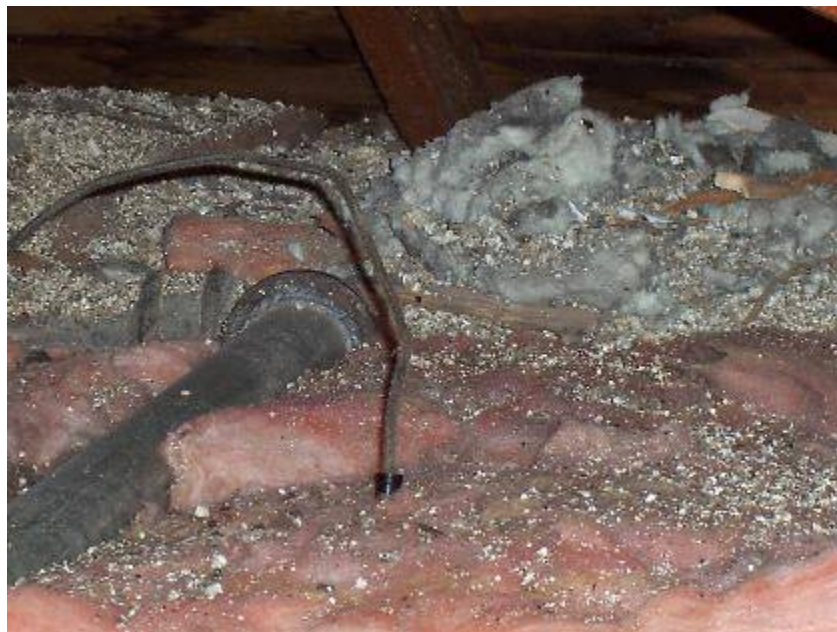
Distribution system \ Wiring - damaged or exposed

Condition: • [Exposed in attics](#)

Implication(s): Health/safety hazard--electric shock

Location: East

Task: Repair

Time: Immediate

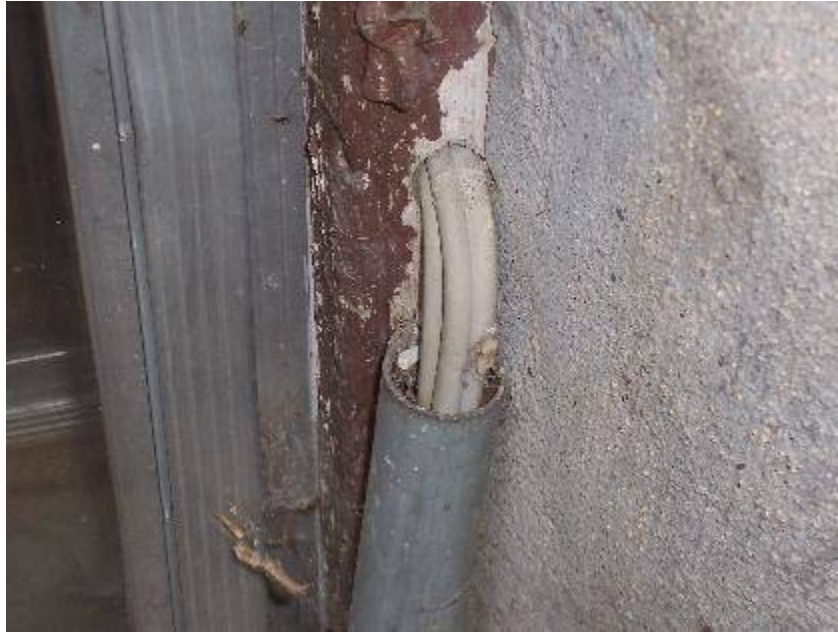
Distribution system \ Wiring - installation

Condition: • Openings in outdoor conduit

Implication(s): water entry in electrical system to garage

Location: west exterior

Task: seal opening

Time: immediate

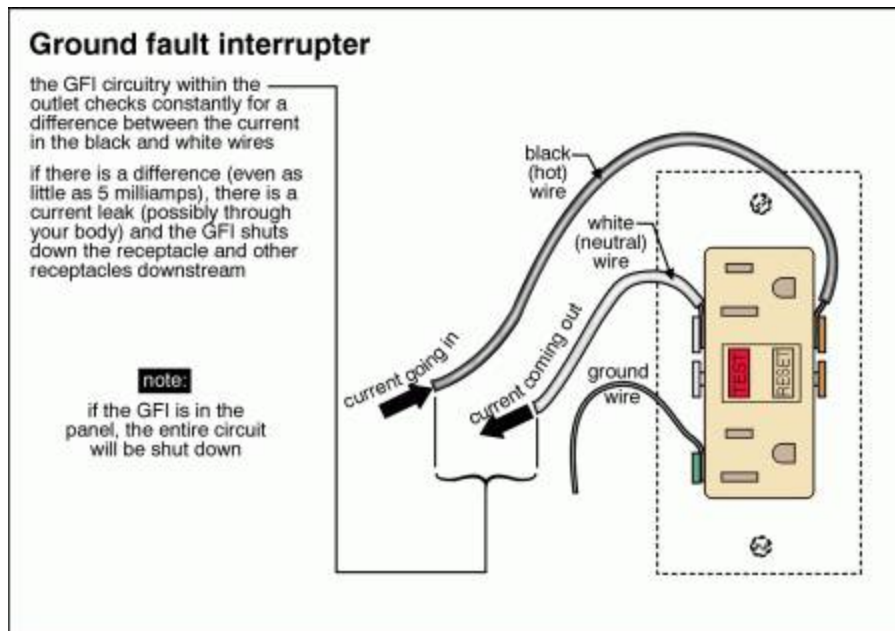
Distribution system \ Outlets

Condition: • [No GFI](#)

Implication(s): Health/safety hazard--electric shock

Location: First floor Bathroom

Task: Provide

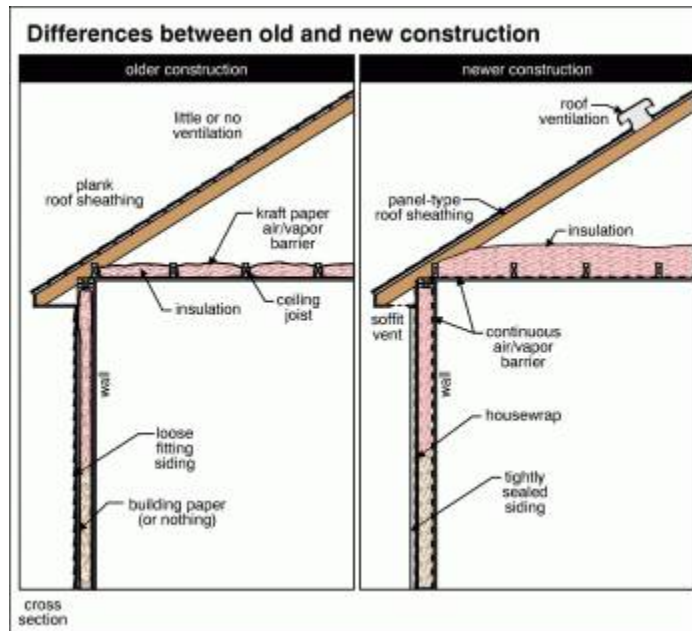
Attic/roof \ Air/vapor barrier

Condition: • [Missing](#)

Implication(s): Risk of condensation damage to finishes and structure | Increased heating and cooling costs | Reduced comfort

Note: Typical for age of house

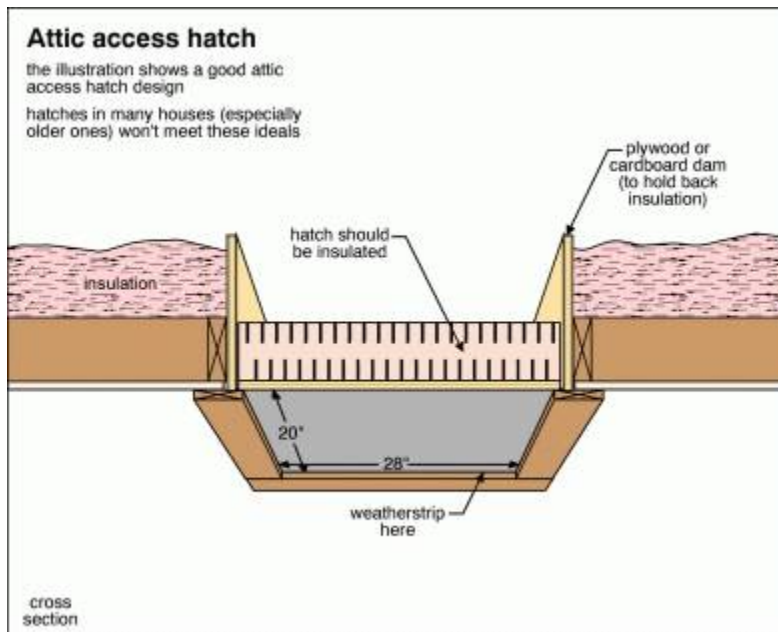
Attic/roof \ Hatch

Condition: • [Not weatherstripped](#)

Implication(s): Increased heating and cooling costs | Reduced comfort

Task: Provide

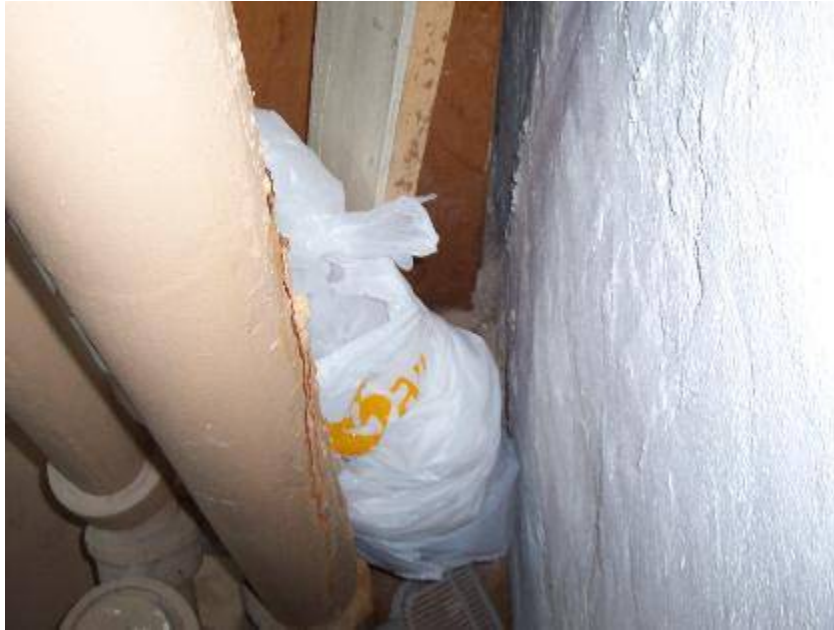
Condition: • [Rust](#)

Implication(s): Health/safety hazard--sewage entering the house

Note: Blistering paint on pipe and some leakage is found

Task: Replace

Time: Less than 1 year

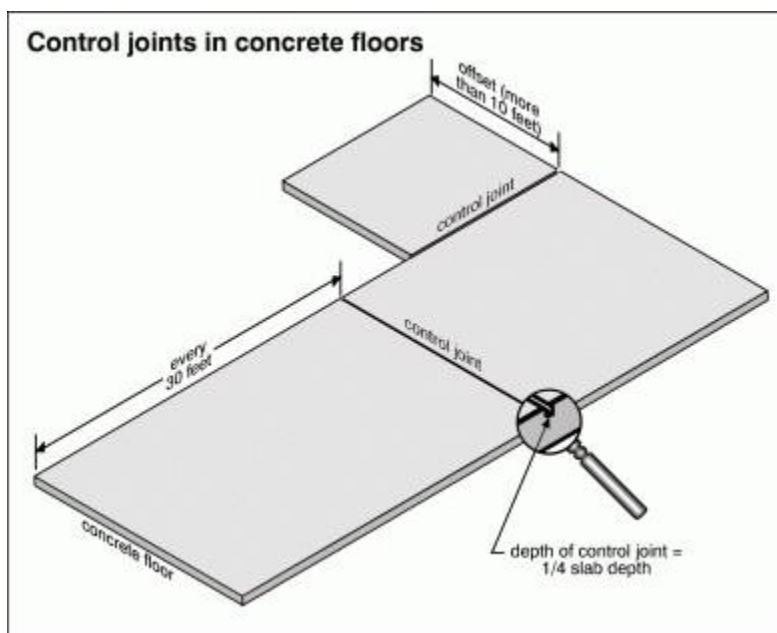
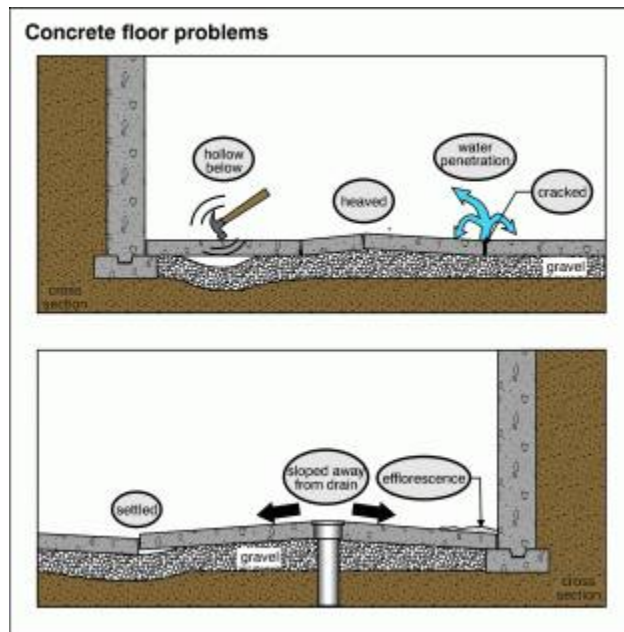
Condition: • [Cracked](#)

Implication(s): Cosmetic defects | Health/safety hazard--trip or fall hazard | Difficult access

Location: basement

Note: typical cracks are noted in basement floor

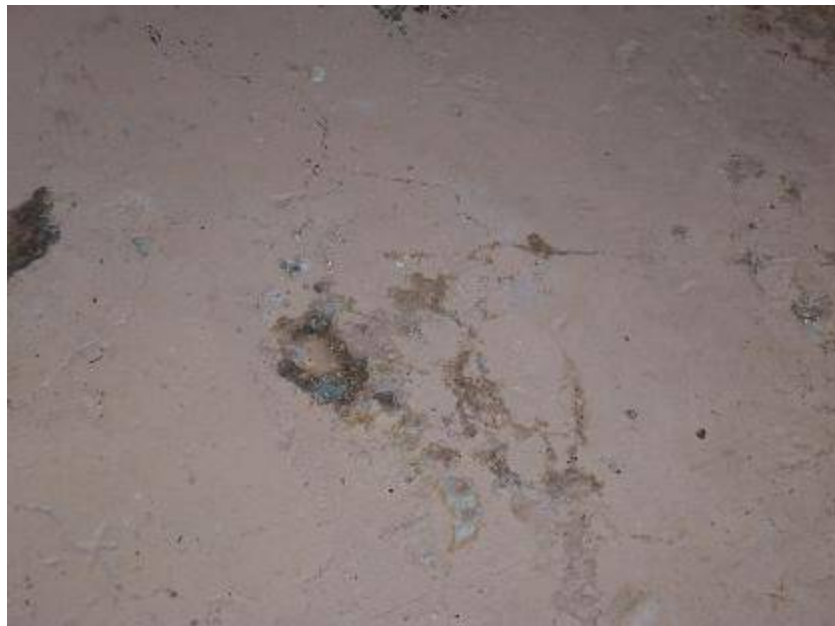
Floors \ Concrete floors

Condition: • [Efflorescence](#)

Implication(s): Cosmetic defects

Location: Basement

Task: Improvement of roof drainage system will probably help with basement efflorescence

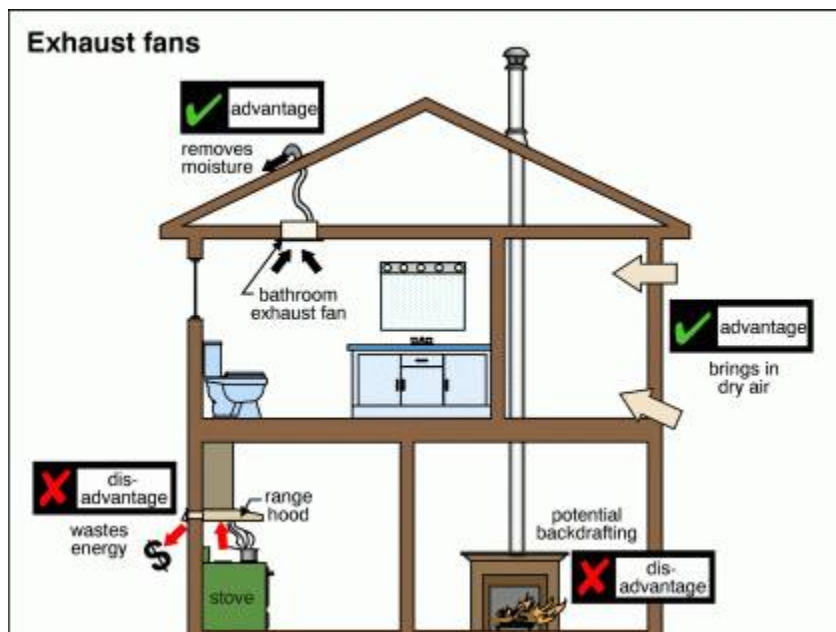
Condition: • [Missing](#)

Implication(s): Risk of condensation damage to finishes and structure

Task: Provide

Time: Immediate
